September 15, 1960

LOCKHEED ELECTRA ACTION PROGRAM

LOCKHEED ELECTRA ACTION PROGRAM (LEAP)

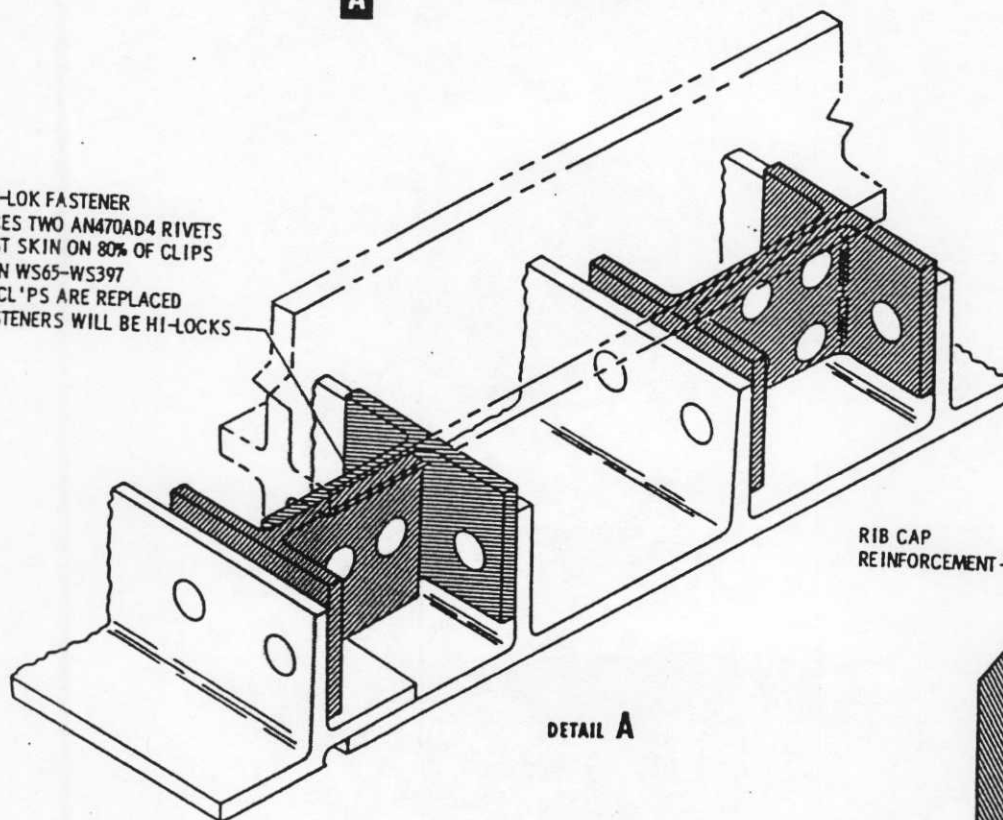
DETAIL A

5/32 HI-LOK FASTENER
REPLACES TWO AN470AD4 RIVETS
NEAREST SKIN ON 80% OF CLIPS
BETWEEN WS65-WS397
WHERE CL'PS ARE REPLACED
ALL FASTENERS WILL BE HI-LOCKS

RIB CAP
REINFORCEMENT

Approximately 80 percent of the "H"-clip to rib cap attachments from W.S. 65 to W.S. 397 will be reworked to replace the two rivets nearest the skin with steel Hi-Lok fasteners.
